TREE SURVEY & ARBORICULTURAL REPORT

Sites at:
**Six land parcels within
The Parish of Great Shelford
Cambridgeshire**

Job ref	Report Version	Author	Checked	Date
ATS0150.1	V1	IL	IL	October 2021

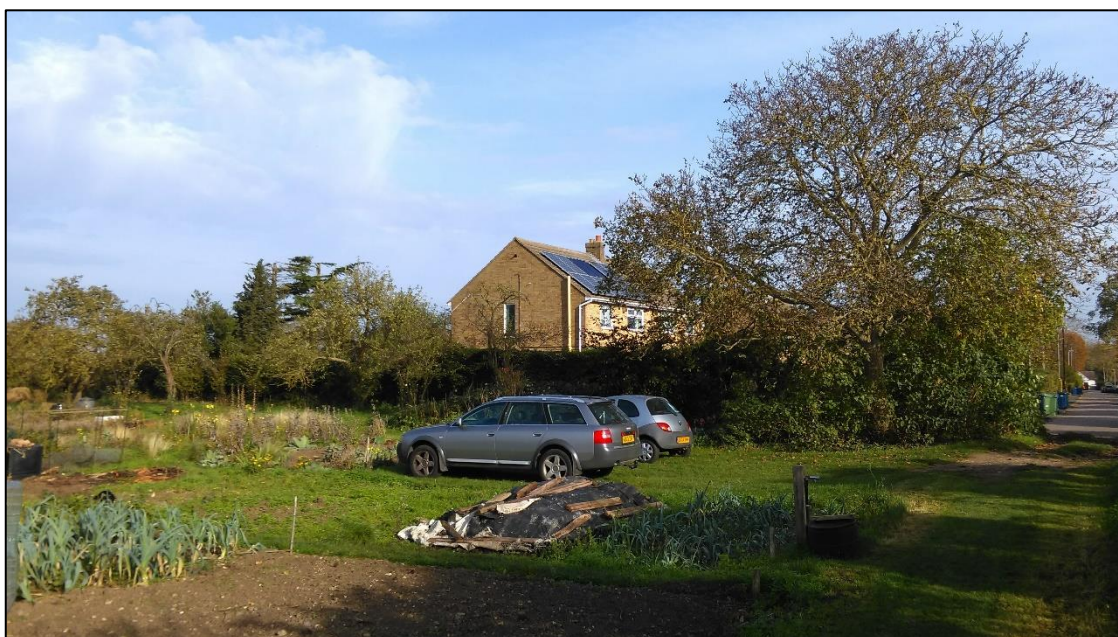
- 5.1 Seven trees are located just to the north of the site entrance off Stonehill Road. Only the Walnut tree (tree 1) is of notable significance.
- 5.2 Two small trees require removal. The Walnut tree requires no work.
- 5.3 Replacement trees are not necessary.
- The photograph below includes all trees present on site

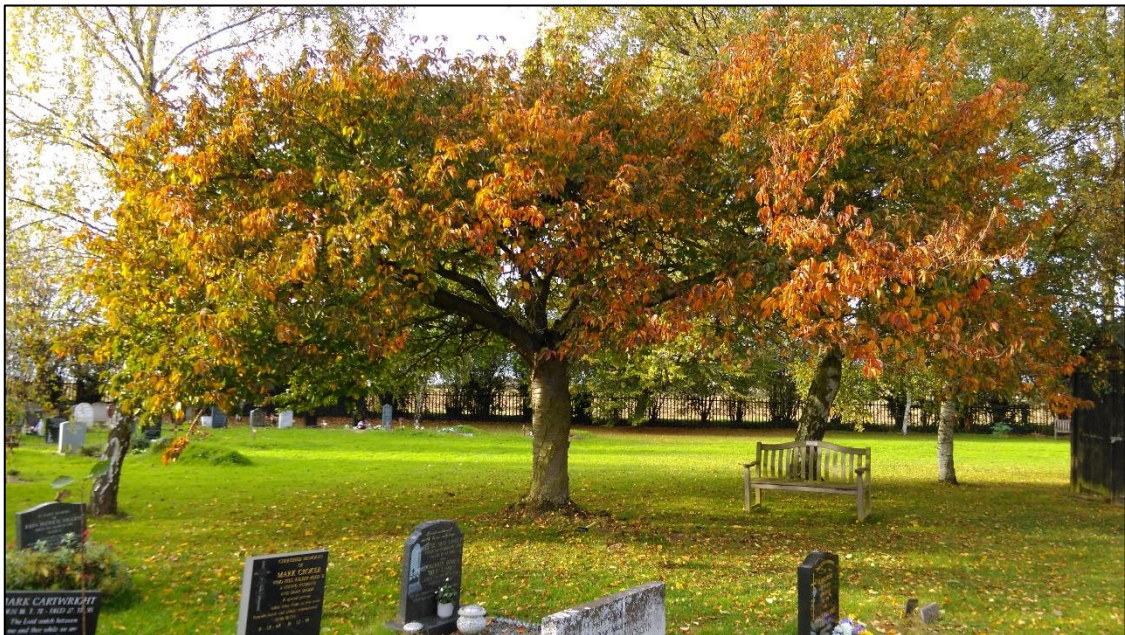
- Below, the Cherry (tree 49)

- 6.1 This is the largest site captured within the survey. 57 trees have been recorded. All but one of the trees are located within the cemetery area or its car park.
- 6.2 One tree requires removal, due to disease and wood decay. A small number of trees require remedial or preventative tree surgery or Ivy severance / removal.
- 6.3 The Japanese Cherry tree (tree 49) could simply be replaced with another Cherry. The *Ganoderma* wood decay fungus is not pathogenic and will not transfer to new plant material.

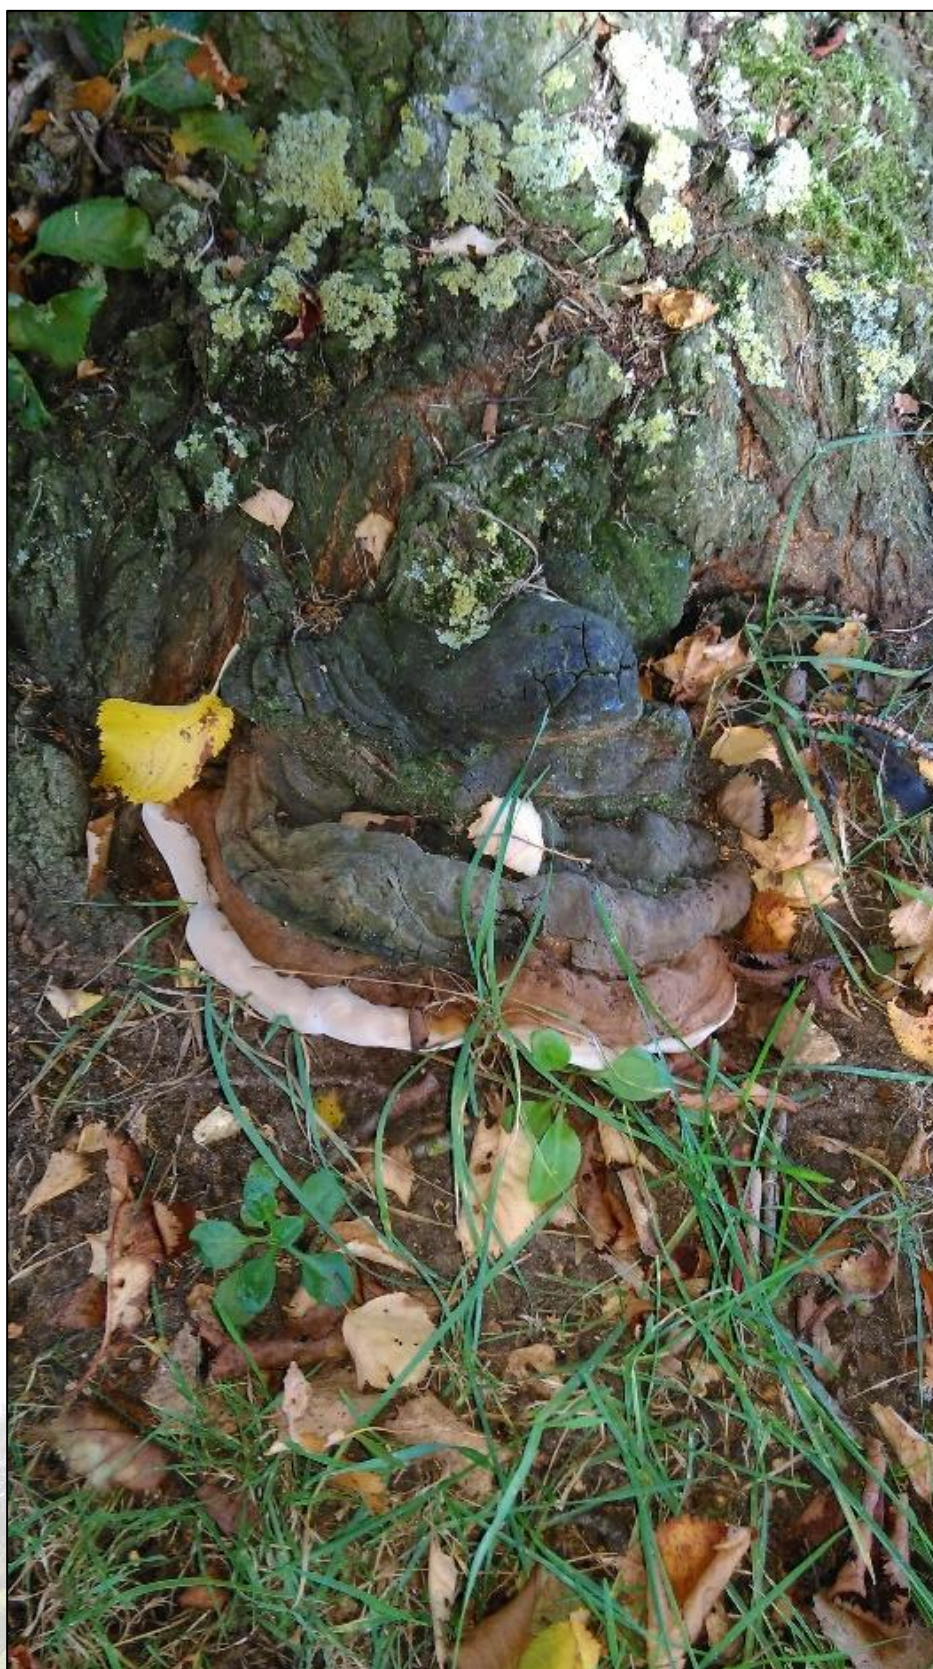
- Below, perennial fungal brackets at base of Cherry 49
