TREE SURVEY & ARBORICULTURAL REPORT

Sites at:
**Six land parcels within
The Parish of Great Shelford
Cambridgeshire**

Job ref	Report Version	Author	Checked	Date
ATS0150.1	V1	IL	IL	October 2021

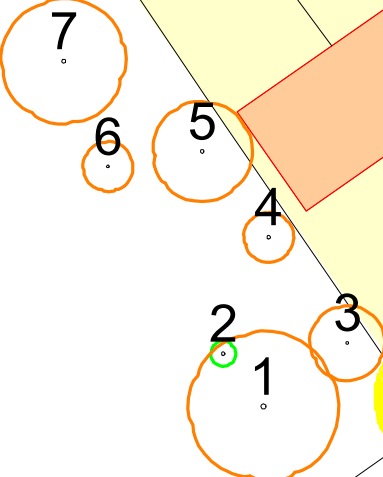
Stonehill Road Allotments
Great Shelford

Site: Stonehill Road Allotments		Date: 15/09/2021					Weather: Dry / Still	
Tree number	Species	Tree height (m)	Stem Dia (s) (mm)	Crown spread (m)	Priority / urgency	Life stage	Observations; structural / physiological condition and any tree work recommendations	Zone value
1	Common Walnut	10.00	400	N 6.0 E 6.0 S 6.0 W 6.0	0	Mature	Low vigour. Minor dead wood mid-crown. Physiological condition - Moderate ▪ No action	2
2	Plum	2.00	200 200	N 1.0 E 1.0 S 1.0 W 1.0	3	Dead	Dead Physiological condition - Dead ▪ Fell	3
3	Wild Cherry	4.50	200	N 3.0 E 3.0 S 3.0 W 3.0	2	Dead	Dead Physiological condition - Dead ▪ Fell	2
4	Plum	5.00	275	N 2.0 E 2.0 S 2.0 W 2.0	0	Over Mature	Top mostly dead. Heavily colonised by <i>Phellinus pomaceus</i> wood decay fungus. Crown health has improved significantly since 2017 Physiological condition - Moderate ▪ No action	2
5	Apple	5.50	100 200 225	N 4.0 E 4.0 S 4.0 W 4.0	0	Mature	Divides into three stems at 0.5 metres. Sound unions. Small dead branches throughout. Becoming overwhelmed by Ivy Physiological condition - Moderate ▪ No action	2

6	Plum	4.00	200	N 2.0 E 2.0 S 2.0 W 2.0	0	Over Mature	Low vigour. Tip dieback Physiological condition - Poor ▪ No action	2
7	Apple	5.00	300	N 5.0 E 5.0 S 5.0 W 5.0	0	Mature	Trunk split at union, shedding three co-dominant stems at 1 metre, leaving only two stems on north-west side. Slightly low vigour Physiological condition - Moderate ▪ No action	2

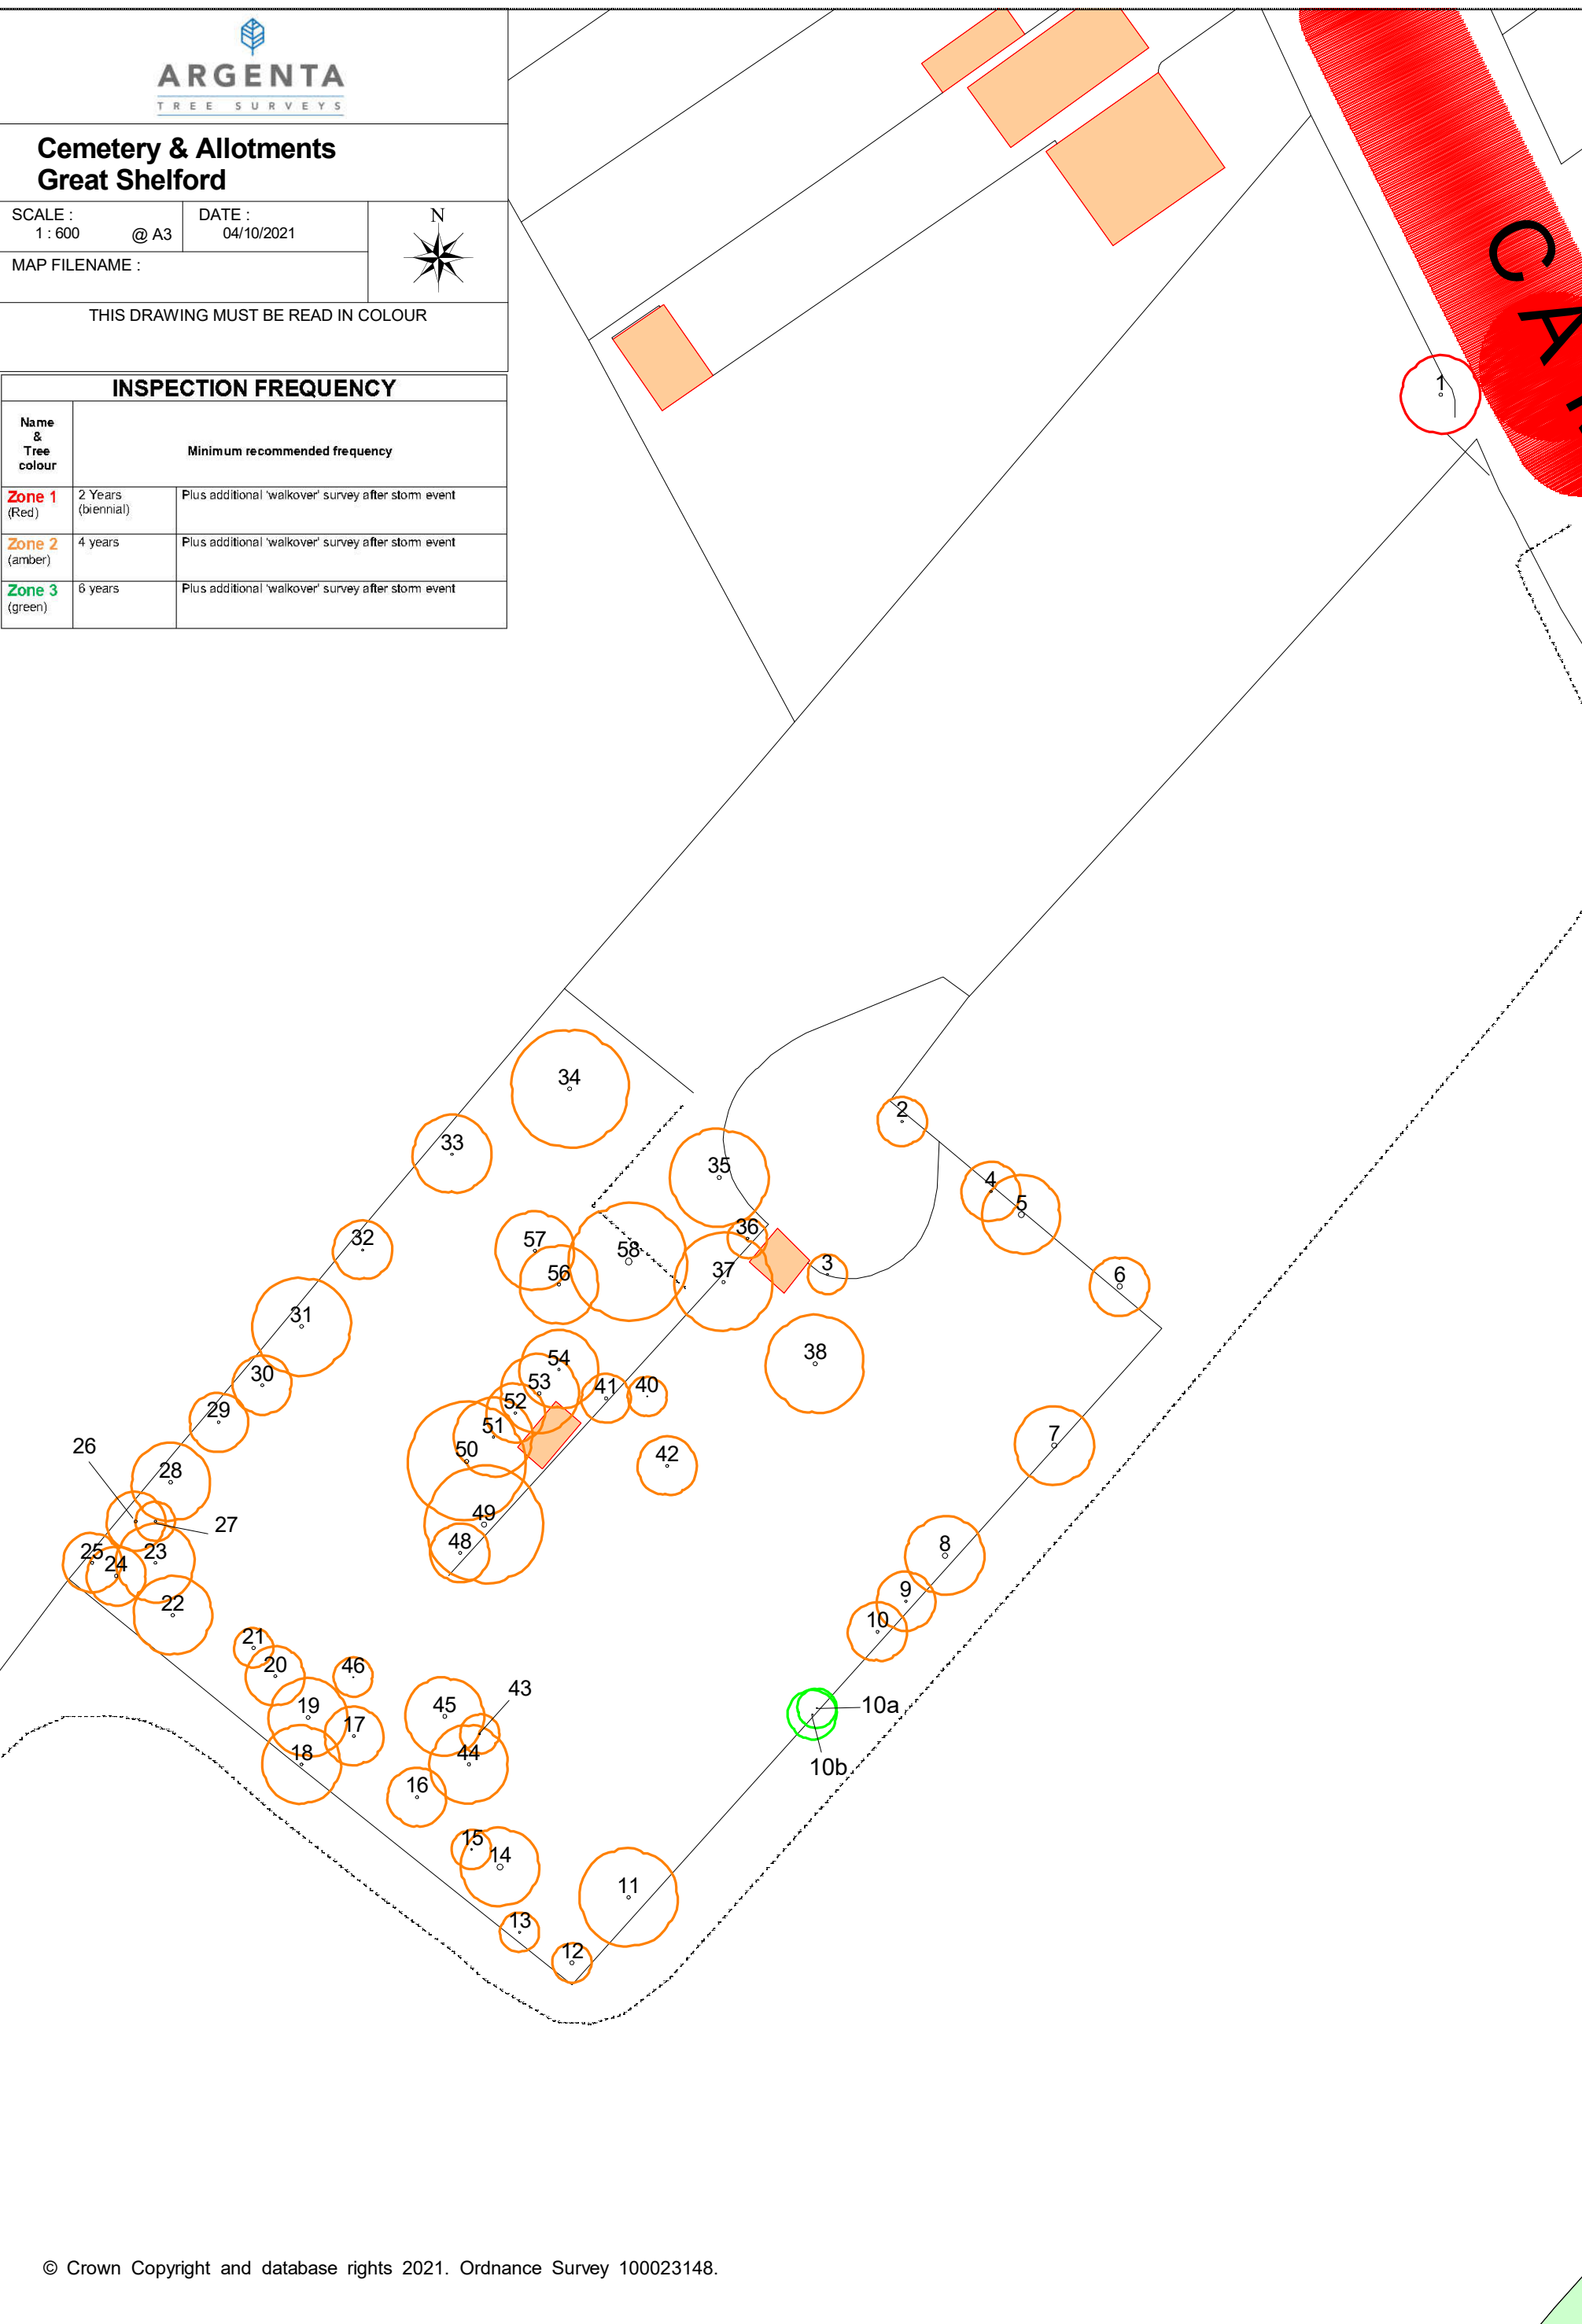
Site: Cemetery & Allotments		Date: 13/09/2021					Weather: Dry / Still	
Tree number	Species	Tree Height (m)	Stem Dia (s) (mm)	Crown spread (m)	Priority / urgency	Life stage	Observations; structural / physiological condition and any tree work recommendations	Zone value
1	Hornbeam	9.00	350	N 4.0 E 4.0 S 4.0 W 4.0	0	Mature	Typical Physiological condition - Good ▪ No action	1
2	Lilac	3.50	250	N 2.5 E 2.5 S 2.5 W 2.5	0	Mature	Considerable dieback Physiological condition - Good ▪ No action	2
3	Lilac	4.00	200	N 2.0 E 2.0 S 2.0 W 2.0	0	Mature	Some dieback on south side. Ivy cover on trunk Physiological condition - Moderate ▪ No action	2
4	Norway Maple	8.00	225	N 3.0 E 3.0 S 3.0 W 3.0	0	Early-mature	Bifurcates into twin co-dominant stems at 2 metres with weak included bark union Physiological condition - Good ▪ No action	2
5	Myrobalan Plum	5.00	600	N 4.0 E 4.0 S 4.0 W 4.0	0	Mature	Very old vertical lesion on trunk. Well occluded. Physiological condition - Good ▪ No action	2

6	Lawson Cypress	8.00	250 250 250 250 250	N 3.0 E 3.0 S 3.0 W 3.0	0	Mature	Typical Physiological condition - Good ▪ No action	2
7	Myrobalan Plum	5.00	500	N 4.0 E 4.0 S 4.0 W 4.0	3	Mature	Ivy cover on trunk and branches Physiological condition - Good ▪ Ivy - Sever/remove ivy	2
8	Lawson Cypress	10.00	200 200 200 300 300	N 4.0 E 4.0 S 4.0 W 4.0	0	Mature	Typical Physiological condition - Good ▪ No action	2

Site: Cemetery & Allotments		Date: 13/09/2021					Weather: Dry / Still	
Tree number	Species	Tree Height (m)	Stem Dia (s) (mm)	Crown spread (m)	Priority / urgency	Life stage	Observations; structural / physiological condition and any tree work recommendations	Zone value
9	Plum	6.00	250	N 3.00 E 3.00 S 3.00 W 3.00	0	Mature	Typical Physiological condition - Good ▪ No action	2
10	Myrobalan Plum	5.00	300	N 3.00 E 3.00 S 3.00 W 3.00	3	Mature	Ivy cover on trunk and branches Physiological condition - Good ▪ Ivy - Sever/remove ivy	2
10a	Beech	7.00	100	N 2.00 E 2.00 S 2.00 W 2.00	0	Early-mature	Typical Physiological condition - Good • No action	3
10b	Beech	9.0	100	N 2.50 E 2.50 S 2.50 W 2.50	0	Early-mature	Typical Physiological condition - Good • No action	3
11	Wild Cherry	10.00	350	N 5.00 E 5.00 S 5.00 W 5.00	0	Mature	Strip of dead bark on one co-dominant stem. Sufficient adaptive growth on underside Physiological condition - Good ▪ No action	2

12	Lawson Cypress	9.00	400	N 2.00 E 2.00 S 2.00 W 2.00	0	Mature	Typical Physiological condition - Good ▪ No action	2
13	Laburnum	4.00	75 75 75 100 100	N 2.00 E 2.00 S 2.00 W 2.00	0	Mature	Divides into five co-dominant stems at 1 metre with weak included bark union. Low vigour Physiological condition - Moderate ▪ No action	2
14	Lawson Cypress	16.00	600	N 4.00 E 4.00 S 4.00 W 4.00	0	Mature	Typical Physiological condition - Good ▪ No action	2

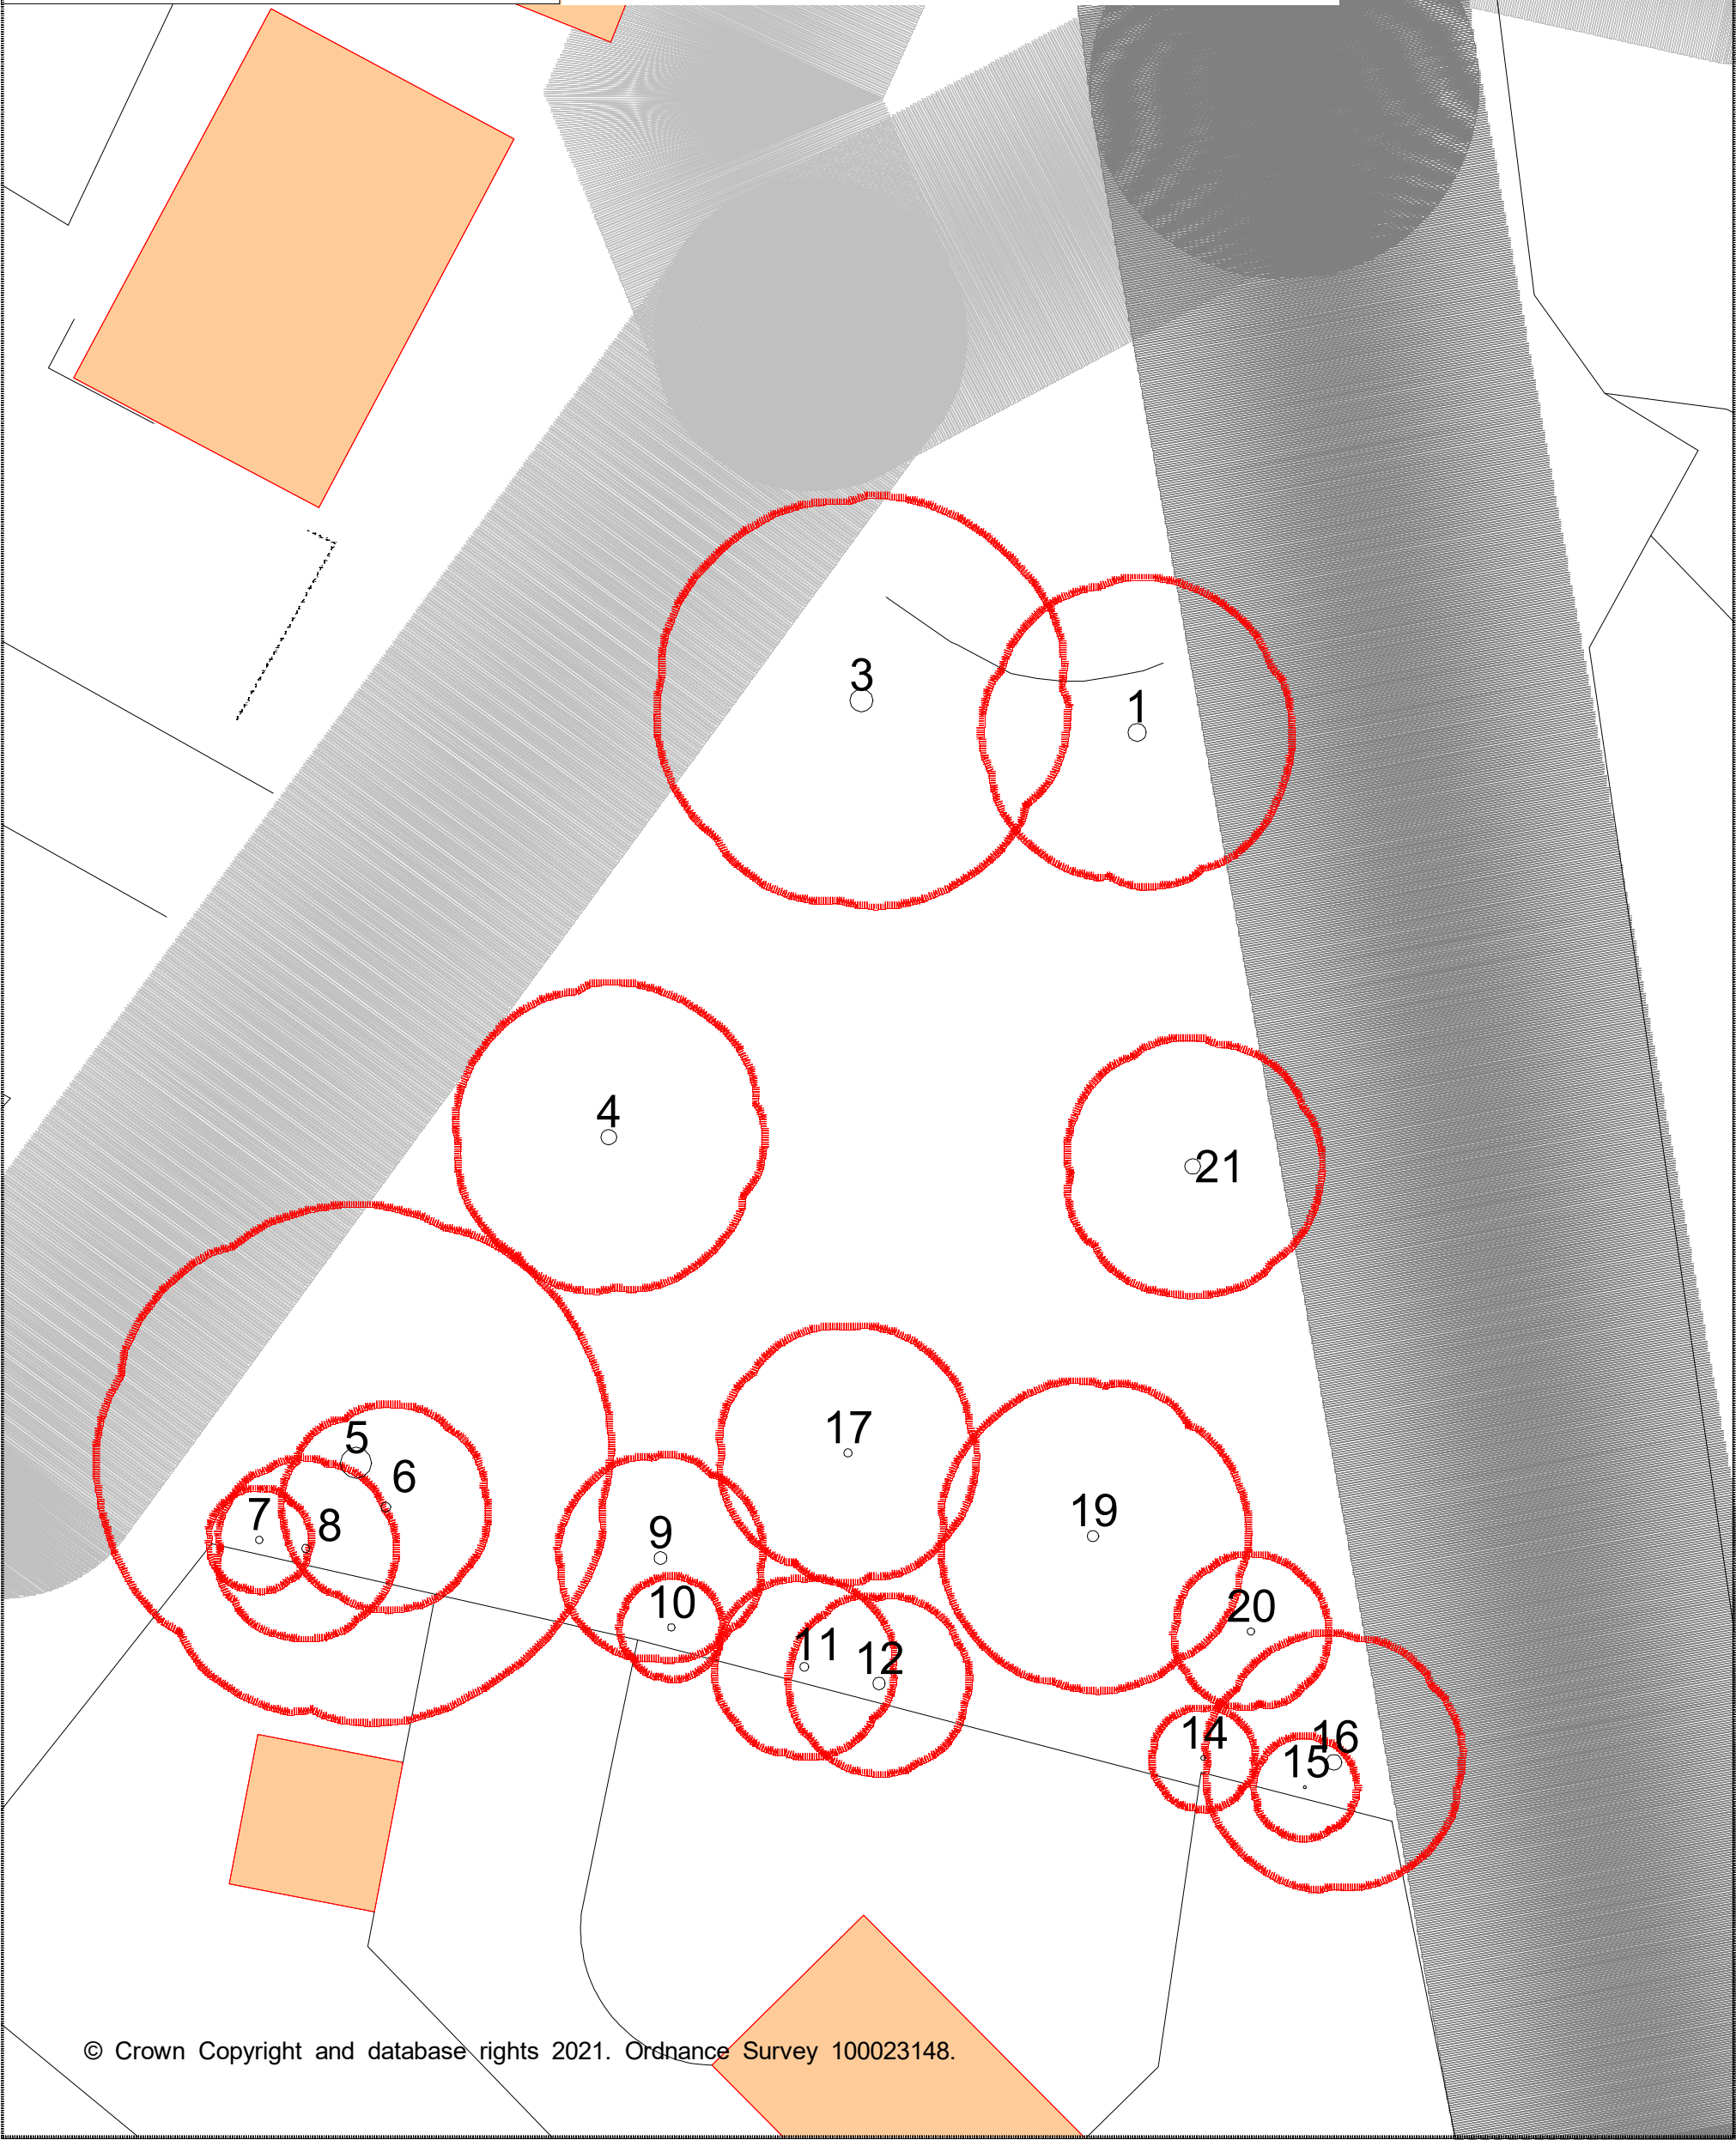
Site: Memorial Green		Date: 15 September 2021					Weather: Dry / Still	
Tree number	Species	Tree height (m)	Stem dia (s) (mm)	Crown spread (m)	Priority / urgency	Life stage	Observations; structural / physiological condition and any tree work recommendations	Zone value
1	Horse Chestnut	17.00	700	N 6.0 E 6.0 S 6.0 W 6.0	0	Mature	Bifurcates into twin co-dominant stems at 3 metres Physiological condition - Good ▪ No action	1
3	Horse Chestnut	20.00	900	N 8.0 E 8.0 S 8.0 W 8.0	0	Mature	Long ago pollarded at 8 metres. Bifurcates into twin co-dominant stems at 4 metres. Areas of dead bark on trunk from ground to 2 metres on east side from previous serious bleeding canker phase (still actively occluding). Several small active canker lesions on north side of trunk. Leaf miner infestation 2 x increment cores taken 15/09/21 revealed no internal decay Physiological condition - Moderate ▪ No action	1
4	Sycamore	21.00	700	N 6.0 E 6.0 S 6.0 W 6.0	0	Mature	Long ago pollarded at 6 metres. Bifurcates into twin co-dominant stems at 3 metres Physiological condition - Good ▪ No action	1

5	London Plane	30.00	1200	N 10.0 E 10.0 S 10.0 W 10.0	1	Mature	Divides into three co-dominant stems at 7 metres. Some small patches of dead bark on trunk on east side at 2 metres. Moderate dead wood in lower crown on south west side over path Physiological condition - Good ▪ Removal dead wood in lower / mid crown	1
6	Common Holly	10.00	250 300	N 4.0 E 4.0 S 4.0 W 4.0	0	Mature	Bifurcates into twin co-dominant stems at 1 metre Physiological condition - Good ▪ No action	1
7	Sycamore	8.00	275	N 2.0 E 2.0 S 2.0 W 2.0	1	Dead	Dead Physiological condition - Dead ▪ Fell	1
8	Elm	12.00	300	N 5.0 E 5.0 S 5.0 W 5.0	0	Semi-mature	Healthy now but expect death from Dutch Elm Disease in next few years. Physiological condition - Good ▪ No action	1

14	Sycamore	12.00	175	N 2.0 E 2.0 S 2.0 W 2.0	2	Semi-mature	Ivy cover on trunk and branches Physiological condition - Moderate ▪ Ivy - Sever/remove ivy	1
15	Ash	5.00	150	N 2.0 E 2.0 S 2.0 W 2.0	2	Mature	Overwhelmed by Ivy Physiological condition - Poor ▪ Remove phototropic side branch projecting towards road back to trunk	1
16	Sycamore	20.00	600	N 5.0 E 5.0 S 5.0 W 5.0	1	Mature	Bifurcates into twin co-dominant stems at 2 metres. Sound union. Small open cavity on western side at ground level (4 x 15cm) - well occluded. Previously pollarded at 7 metres. Moderate dead wood throughout. Physiological condition - Moderate ▪ Remove major dead wood	1

Site: Memorial Green		Date: 15 September 2021					Weather: Dry / Still	
Tree number	Species	Tree height (m)	Stem dia (s) (mm)	Crown spread (m)	Priority / urgency	Life stage	Observations; structural / physiological condition and any tree work recommendations	Zone value
17	Cherry Laurel	6.00	150 150 150 150 150	N 7.0 E 7.0 S 7.0 W 7.0	0	Mature	Many stems at base. Wide spreading Physiological condition - Good ▪ No action	1
19	Sycamore	21.00	450	N 6.0 E 6.0 S 6.0 W 6.0	0	Mature	Bifurcates into twin co-dominant stems at 10 metres. Sound union Physiological condition - Good ▪ No action	1
20	Ash	19.00	300	N 4.0 E 4.0 S 4.0 W 4.0	0	Mature	Bifurcates into twin co-dominant stems at 3 metres. Sound union. Minor dead wood in mid crown Physiological condition - Good ▪ No action	1
21	Sycamore	20.00	600	N 6.0 E 6.0 S 6.0 W 6.0	0	Mature	Divides into three co-dominant stems at 2.5 metres. Water pocket in fork. Strong union. Previously pollarded at 6 metres Physiological condition - Good ▪ No action	1

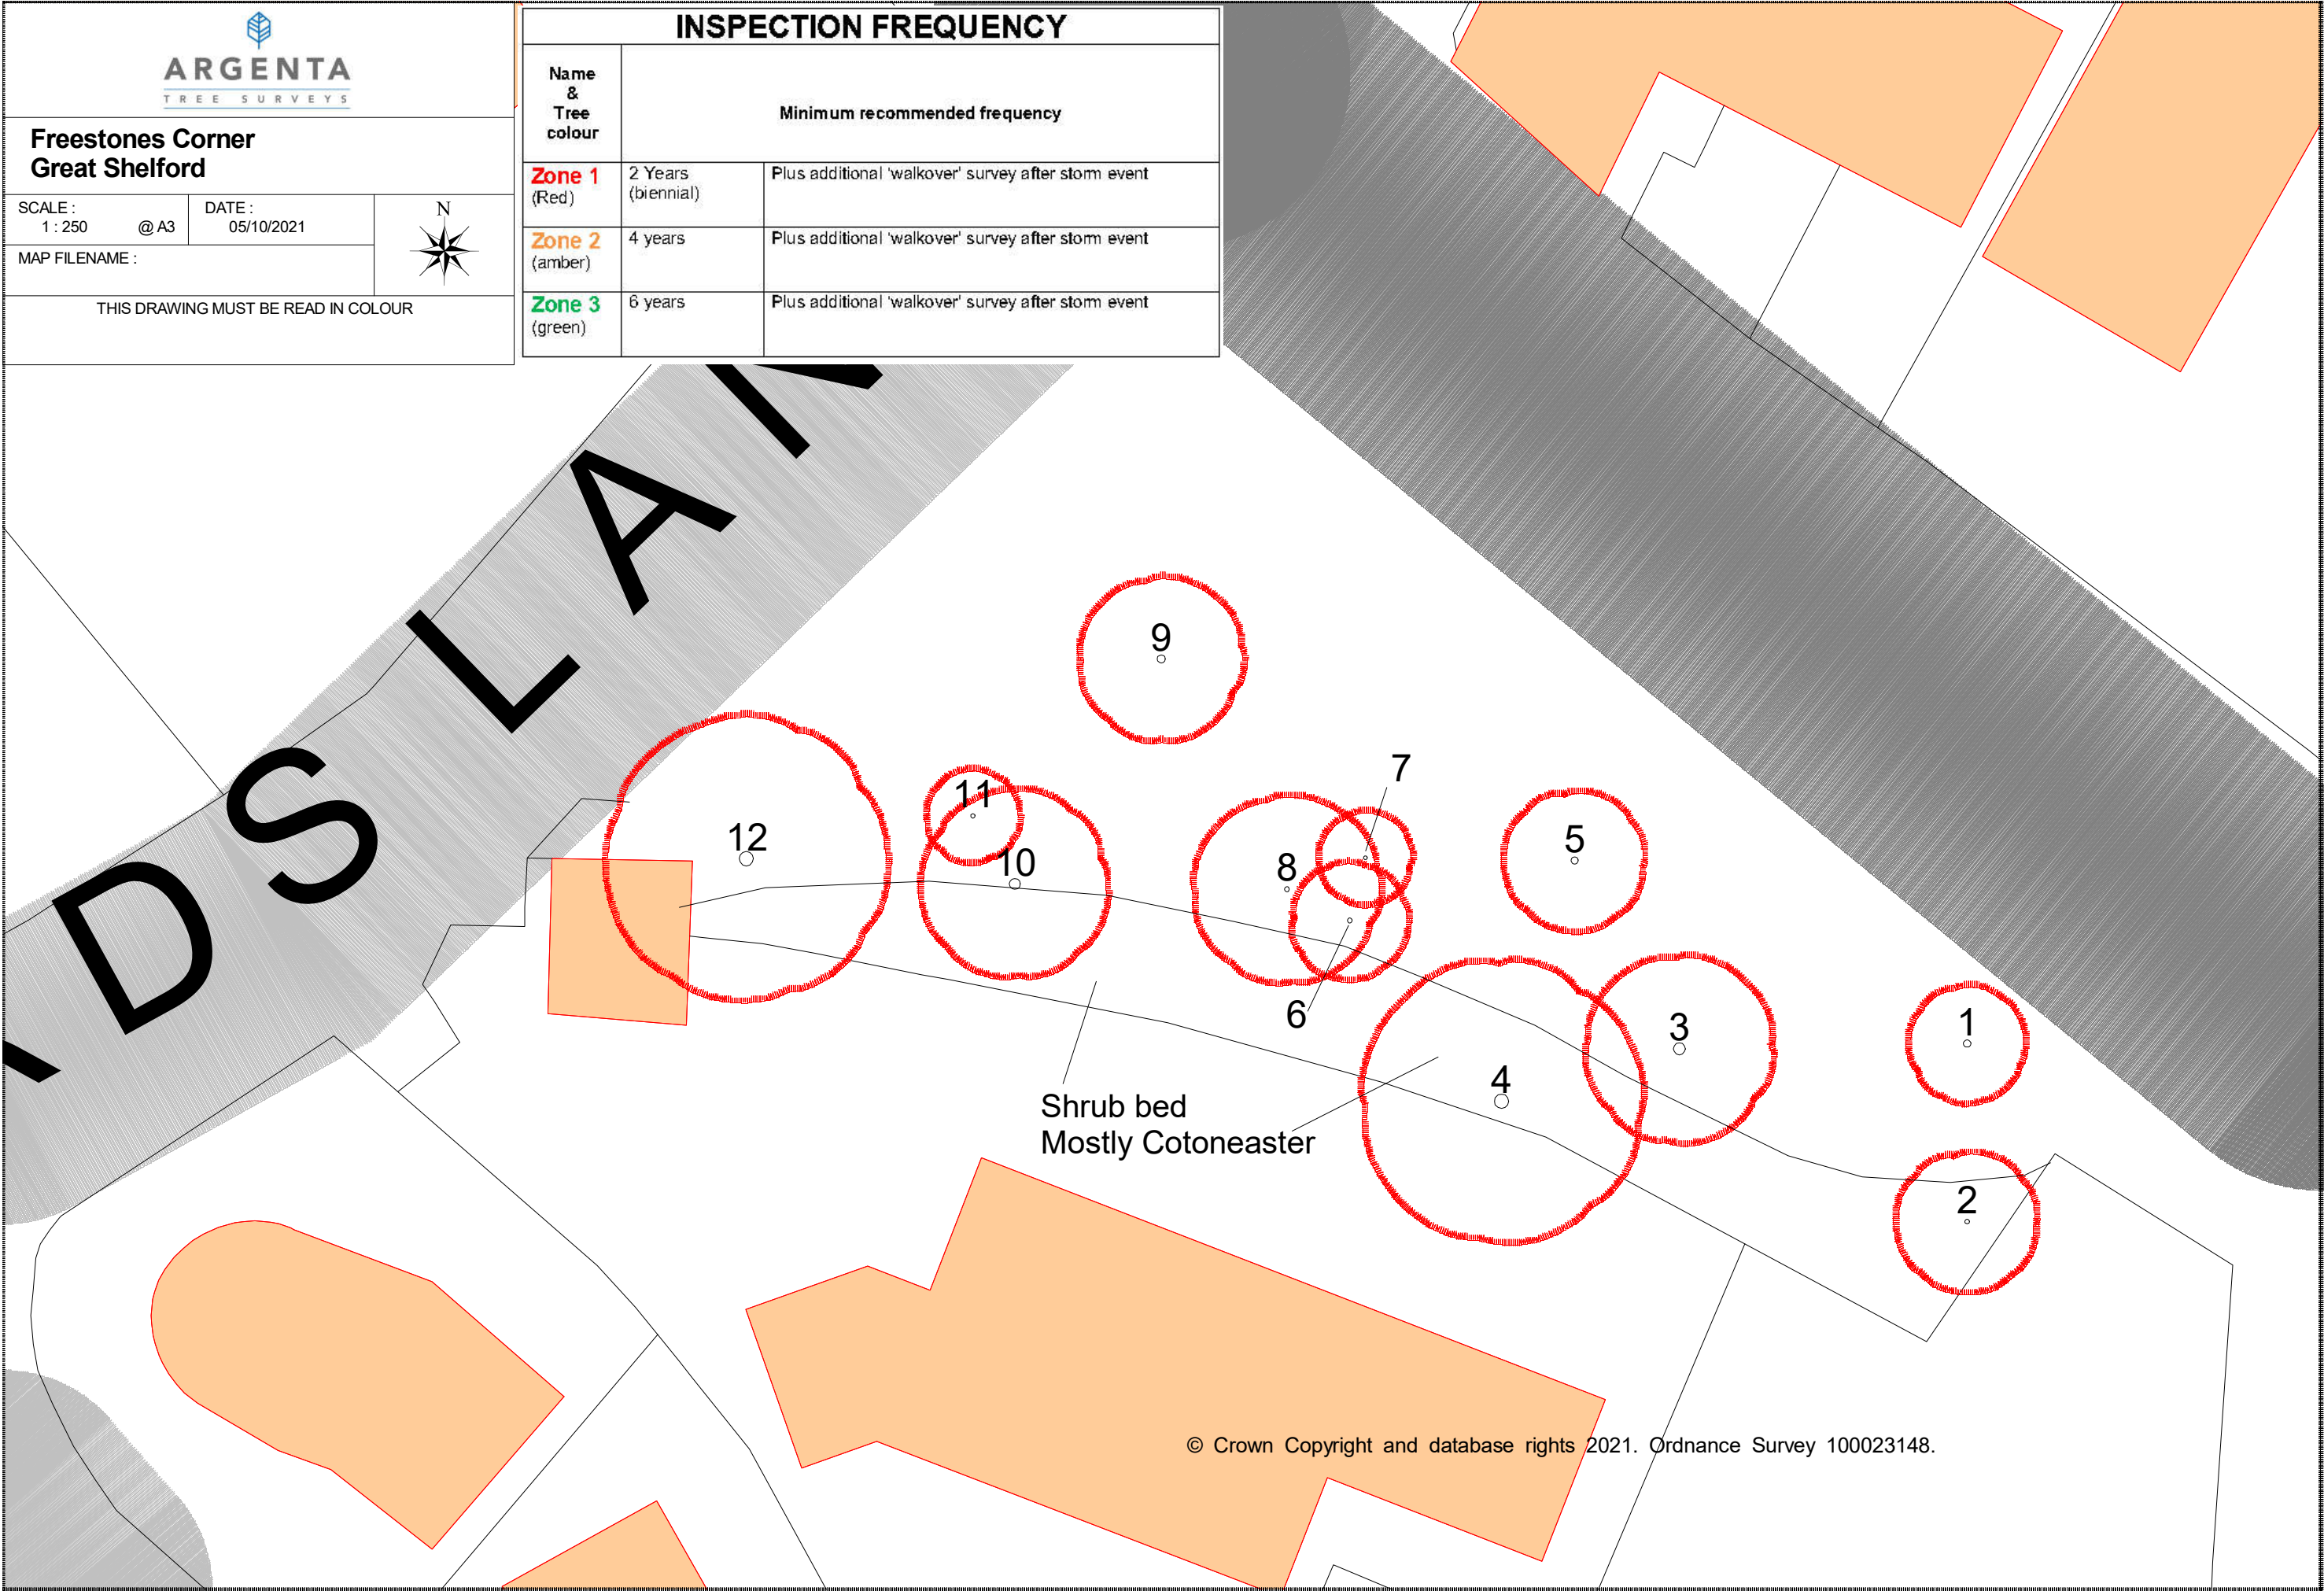
Site: Freestones Corner		Date: 14/09/2021					Weather: Dry / Still	
Tree number	Species	Tree Height (m)	Stem Dia (s) (mm)	Crown Spread (m)	Priority / urgency	Life stage	Observations; structural / physiological condition and any tree work recommendations	Zone value
1	Lawson Cypress (Bright green cultivar)	10.00	300	N 3.0 E 3.0 S 3.0 W 3.0	0	Mature	No notable defects Physiological condition - Good ▪ No action	1
2	Ash	10.00	250	N 3.0 E 3.0 S 3.0 W 3.0	0	Semi-mature	Lean to north east due to light competition Physiological condition - Good ▪ No action	1
3	Sycamore	15.00	500	N 4.0 E 4.0 S 4.0 W 4.0	2	Mature	Minor dead wood throughout. Ivy cover on trunk. Physiological condition - Moderate ▪ Ivy - Sever/remove Ivy	1
4	Sycamore	17.00	600	N 6.0 E 6.0 S 6.0 W 6.0	2	Mature	Ivy cover on trunk and branches. Bifurcates into twin co-dominant stems at 1 metre (with included bark union but with natural grafts improving strength) Physiological condition - Moderate ▪ Ivy - Sever/remove Ivy	1

5	Oak	17.00	300	N 4.0 E 4.0 S 4.0 W 4.0	0	Semi-mature	Excellent specimen Physiological condition - Good ▪ No action	1
6	Cherry	5.00	200	N 2.5 E 2.5 S 2.5 W 2.5	0	Mature	Typical Physiological condition - Good ▪ No action	1
7	Cherry	4.00	150	N 2.0 E 2.0 S 2.0 W 2.0	0	Mature	Bifurcates into twin co-dominant stems at 1 metre. From ground level to 1 metre on north side - Raised rib weeping sap - likely Cherry Canker Disease. Low vigour Physiological condition - Poor ▪ No action	1

Site: Freestones Corner		Date: 14/09/2021					Weather: Dry / Still	
Tree number	Species	Tree Height (m)	Stem Dia (s) (mm)	Crown Spread (m)	Priority / urgency	Life stage	Observations; structural / physiological condition and any tree work recommendations	Zone value
8	Cherry	5.00	200	N 4.0 E 4.0 S 4.0 W 4.0	0	Mature	Typical Physiological condition - Good ▪ No action	1
9	Lime	16.00	350	N 4.0 E 4.0 S 4.0 W 4.0	0	Mature	Divides into three co-dominant stems at 3 metres. Sound union Physiological condition - Good ▪ No action	1
10	Sycamore	12.00	300 350	N 4.0 E 4.0 S 4.0 W 4.0	2	Mature	Bifurcates into twin co-dominant stems at base. Ivy cover on trunk and branches Physiological condition - Good ▪ Ivy - Sever/remove Ivy	1
11	Yew	7.00	175	N 3.0 E 3.0 S 3.0 W 3.0	0	Semi-mature	Typical Physiological condition - Good ▪ No action	1
12	Narrowleaf Ash	20.00	600	N 6.0 E 6.0 S 6.0 W 6.0	1	Mature	Moderate dead wood in mid crown Physiological condition - Good ▪ Remove major dead wood	1

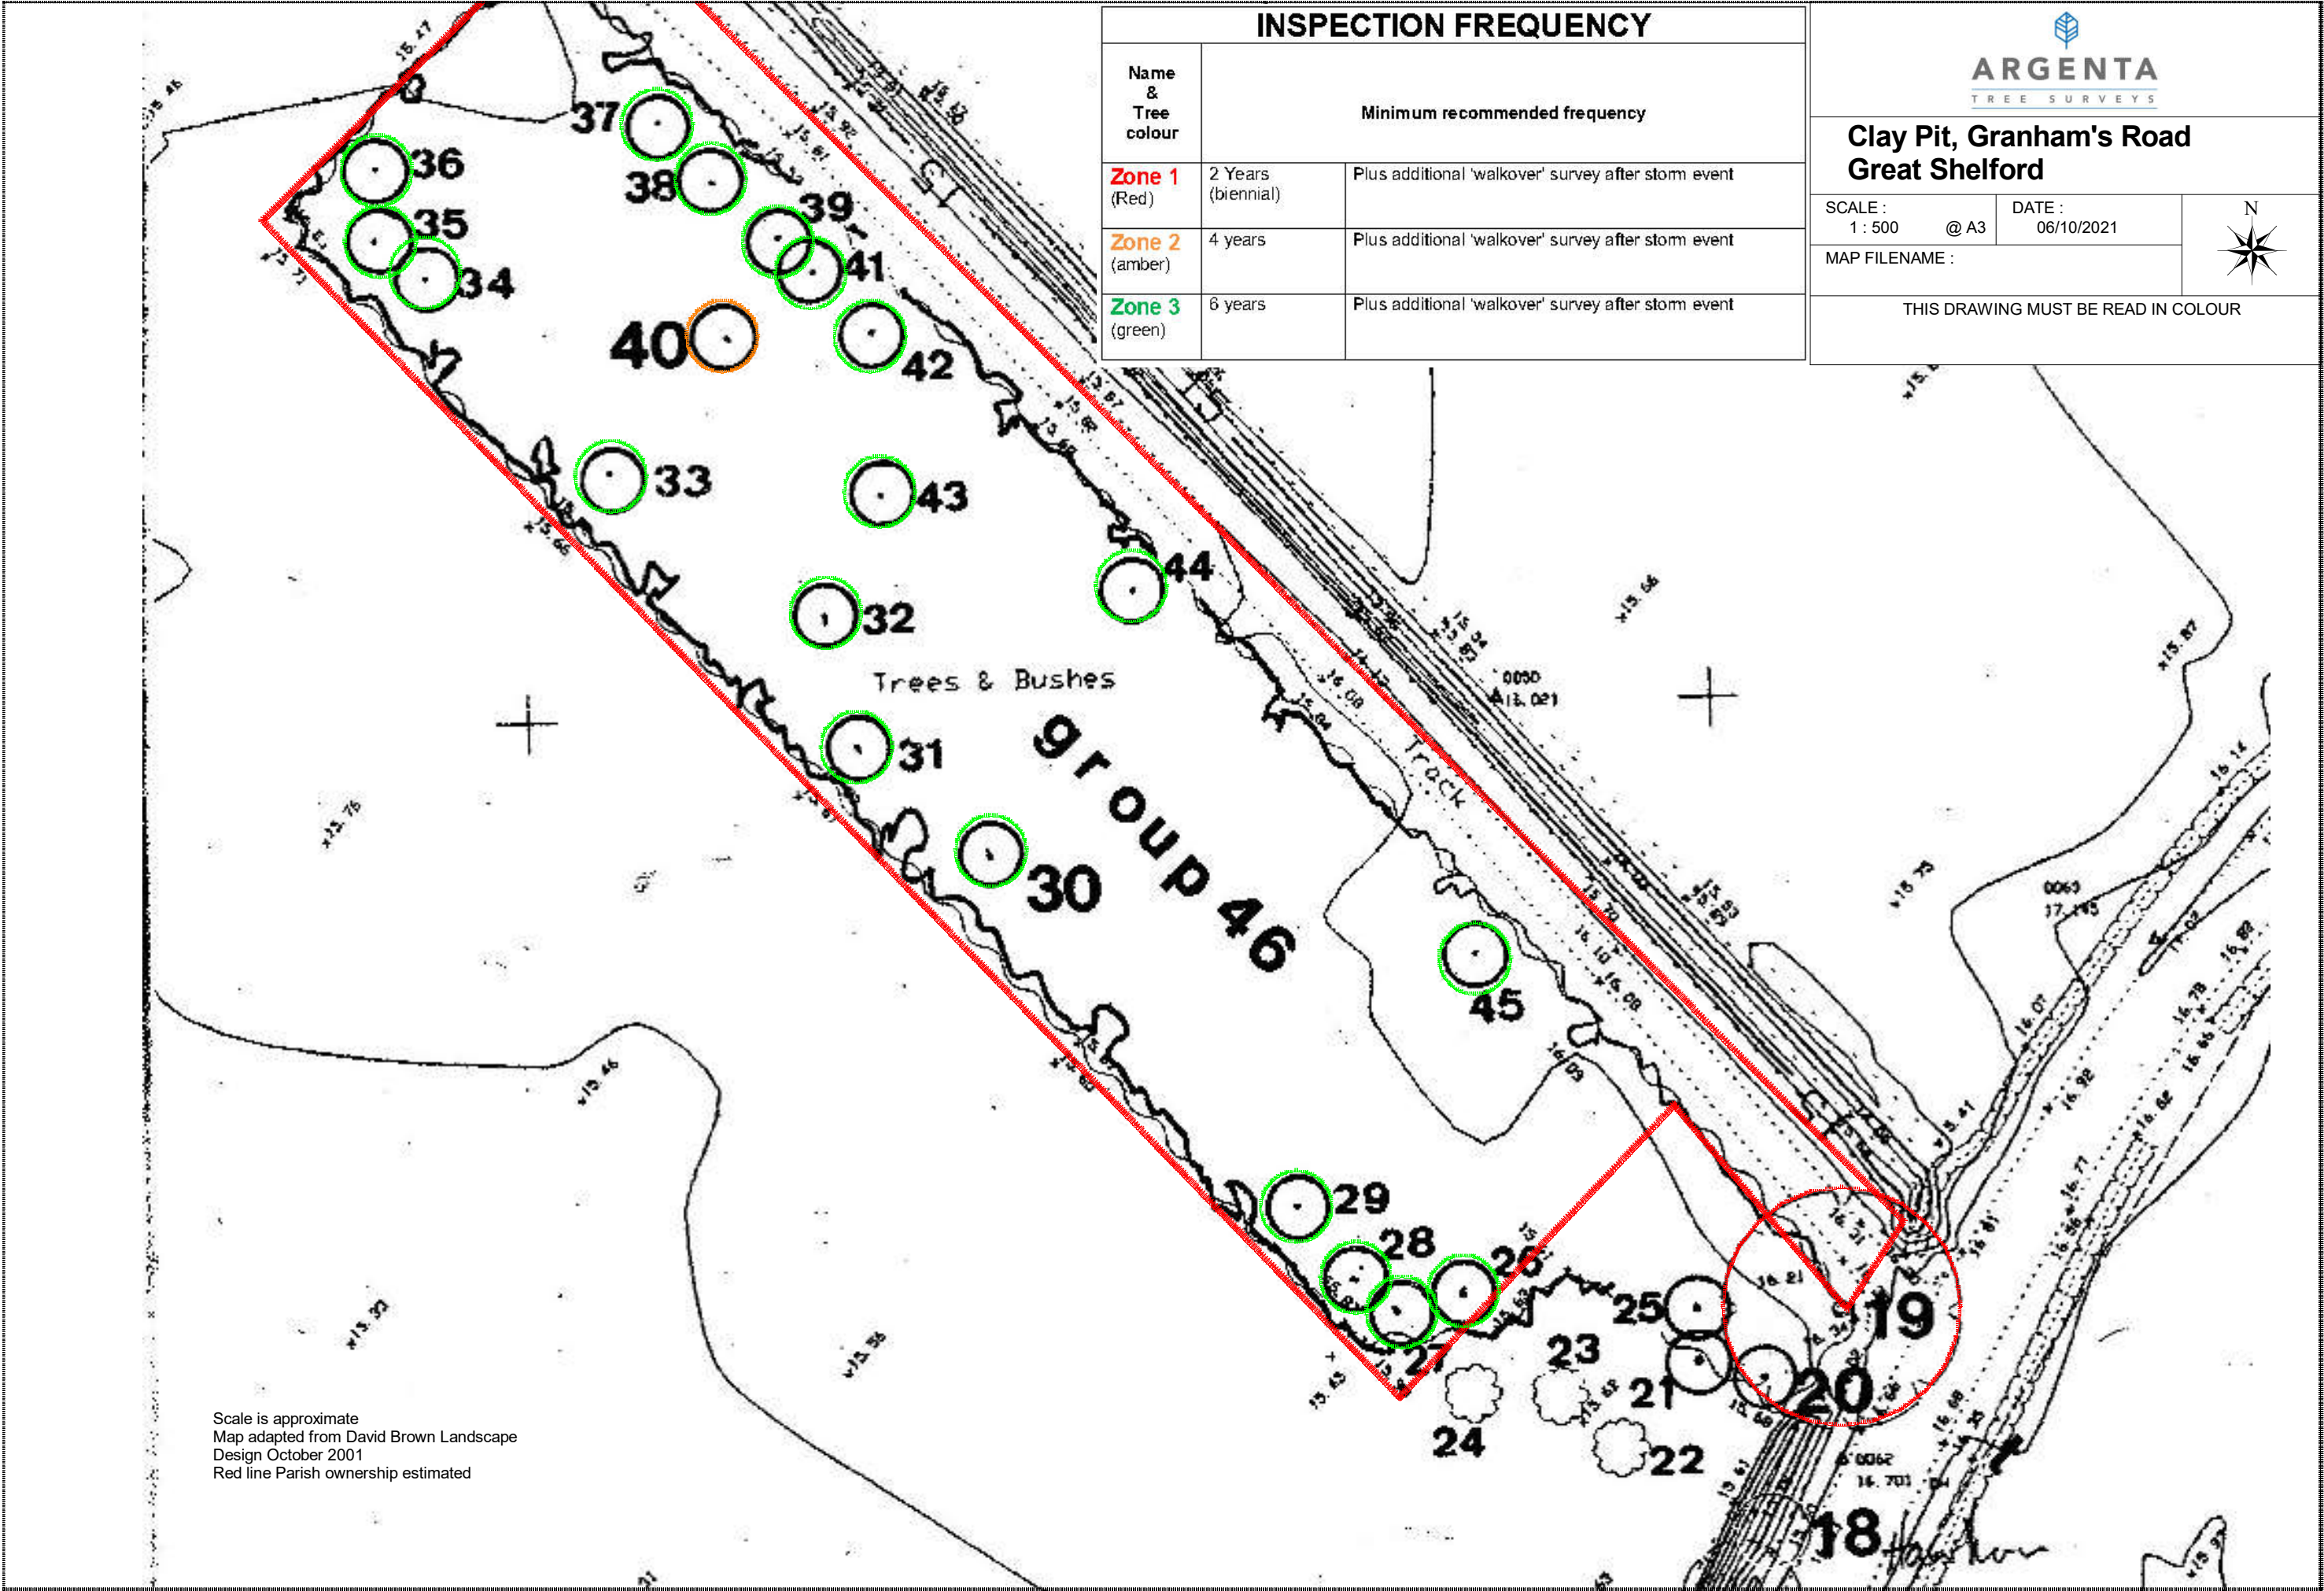
Site: Clay Pit, Granham's Road		Date: 14/09/2021					Weather: Dry / Still	
Tree number	Species	Tree Height (m)	Stem Dia (s) (mm)	Crown Spread (m)	Priority / urgency	Life stage	Observations; structural / physiological condition and any tree work recommendations	Zone value
19	Ash	16.00	1000	N 8.0 E 8.0 S 8.0 W 8.0	0	Mature	Previously reduced over road. Ivy cover on trunk. Early signs of Ash Dieback Disease Physiological condition - Good ▪ No action	1
26	Sycamore	12.00	300	N 5.0 E 5.0 S 5.0 W 5.0	0	Mature	Bifurcates into twin co-dominant stems at 2 metres. Ivy cover on trunk Physiological condition - Good ▪ No action	3
27	Ash	13.00	650	N 5.0 E 5.0 S 5.0 W 5.0	0	Mature	Bifurcates into twin co-dominant stems at 2 metres. Weak included bark union. Crown mass biased southwest Physiological condition - Moderate ▪ No action	3
28	Sycamore	13.00	450	N 5.0 E 5.0 S 5.0 W 5.0	0	Mature	Tar Spot of Sycamore (fungal leaf spot – of no concern) Physiological condition - Moderate ▪ No action	3

29	Goat Willow	14.00	400 500 400 350 400	N E 10.0 S W	0	Over Mature	Ivy cover on trunks. Multiple stems from base Physiological condition - Moderate ▪ No action	3
30	Ash	12.00	450	N 6.0 E 6.0 S 6.0 W 6.0	0	Mature	Ivy cover on trunk Physiological condition - Good ▪ No action	3
31	Sycamore	12.00	550	N 5.0 E 5.0 S 5.0 W 5.0	0	Mature	Divides into three co-dominant stems at 2 metres. Minor dead wood in mid crown Physiological condition - Good ▪ No action	3
32	Wild Cherry	12.00	300 275	N 4.0 E 4.0 S 4.0 W 4.0	0	Mature	Considerable dead wood in crown on western side due to light competition. Bifurcates into twin co-dominant stems at 1.5 metres Physiological condition - Moderate ▪ No action	3

37	Sycamore	12.00	400	N 4.0% E 4.0% S 4.0% W 4.0%	0	Mature	Bifurcates into twin co-dominant stems at 2 metres. Weak included bark union. Also multiple weak included bark union unions (poor genetic stock). Physiological condition - Moderate ▪ No action	3
38	Ash	10.00	275	N 4.0% E 4.0% S 4.0% W 4.0%	0	Mature	Typical Physiological condition - Good ▪ No action	3
39	Sycamore	10.00	400	N 5.0% E 5.0% S 5.0% W 5.0%	0	Mature	Some moderate dead wood in lower crown due to light competition Physiological condition - Moderate ▪ No action	3
40	Ash	12.00	350	N 5.0% E 5.0% S 5.0% W 5.0%	1	Mature	Significant dead wood in lower crown due to light competition Physiological condition - Good ▪ Remove major dead wood (Overhangs bench)	2

Site: Clay Pit, Granham's Road		Date: 14/09/2021					Weather: Dry / Still	
Tree number	Species	Tree Height (m)	Stem Dia (s) (mm)	Crown Spread (m)	Priority / urgency	Life stage	Observations; structural / physiological condition and any tree work recommendations	Zone value
41	Ash	12.00	450	N 5.0% E 5.0% S 5.0% W 5.0%	0	Mature	Some moderate dead wood in lower crown due to light competition Physiological condition - Good ▪ No action	3
42	Field Maple	12.00	500	N 6.0% E 6.0% S 6.0% W 6.0%	0	Mature	Typical Physiological condition - Good ▪ No action	3
43	Horse Chestnut	10.00	300	N 4.0% E 4.0% S 4.0% W 4.0%	0	Mature	Chronic long term bleeding canker and leaf miner infestation. Low vigour. Moderate small diameter dead wood Physiological condition - Poor ▪ No action	3
44	Sycamore	14.00	450	N 5.0% E 5.0% S 5.0% W 5.0%	0	Mature	Typical Physiological condition - Good ▪ No action	3
45	Sycamore	14.00	500	N 6.0% E 6.0% S 6.0% W 6.0%	0	Mature	Typical Physiological condition - Good ▪ No action	3

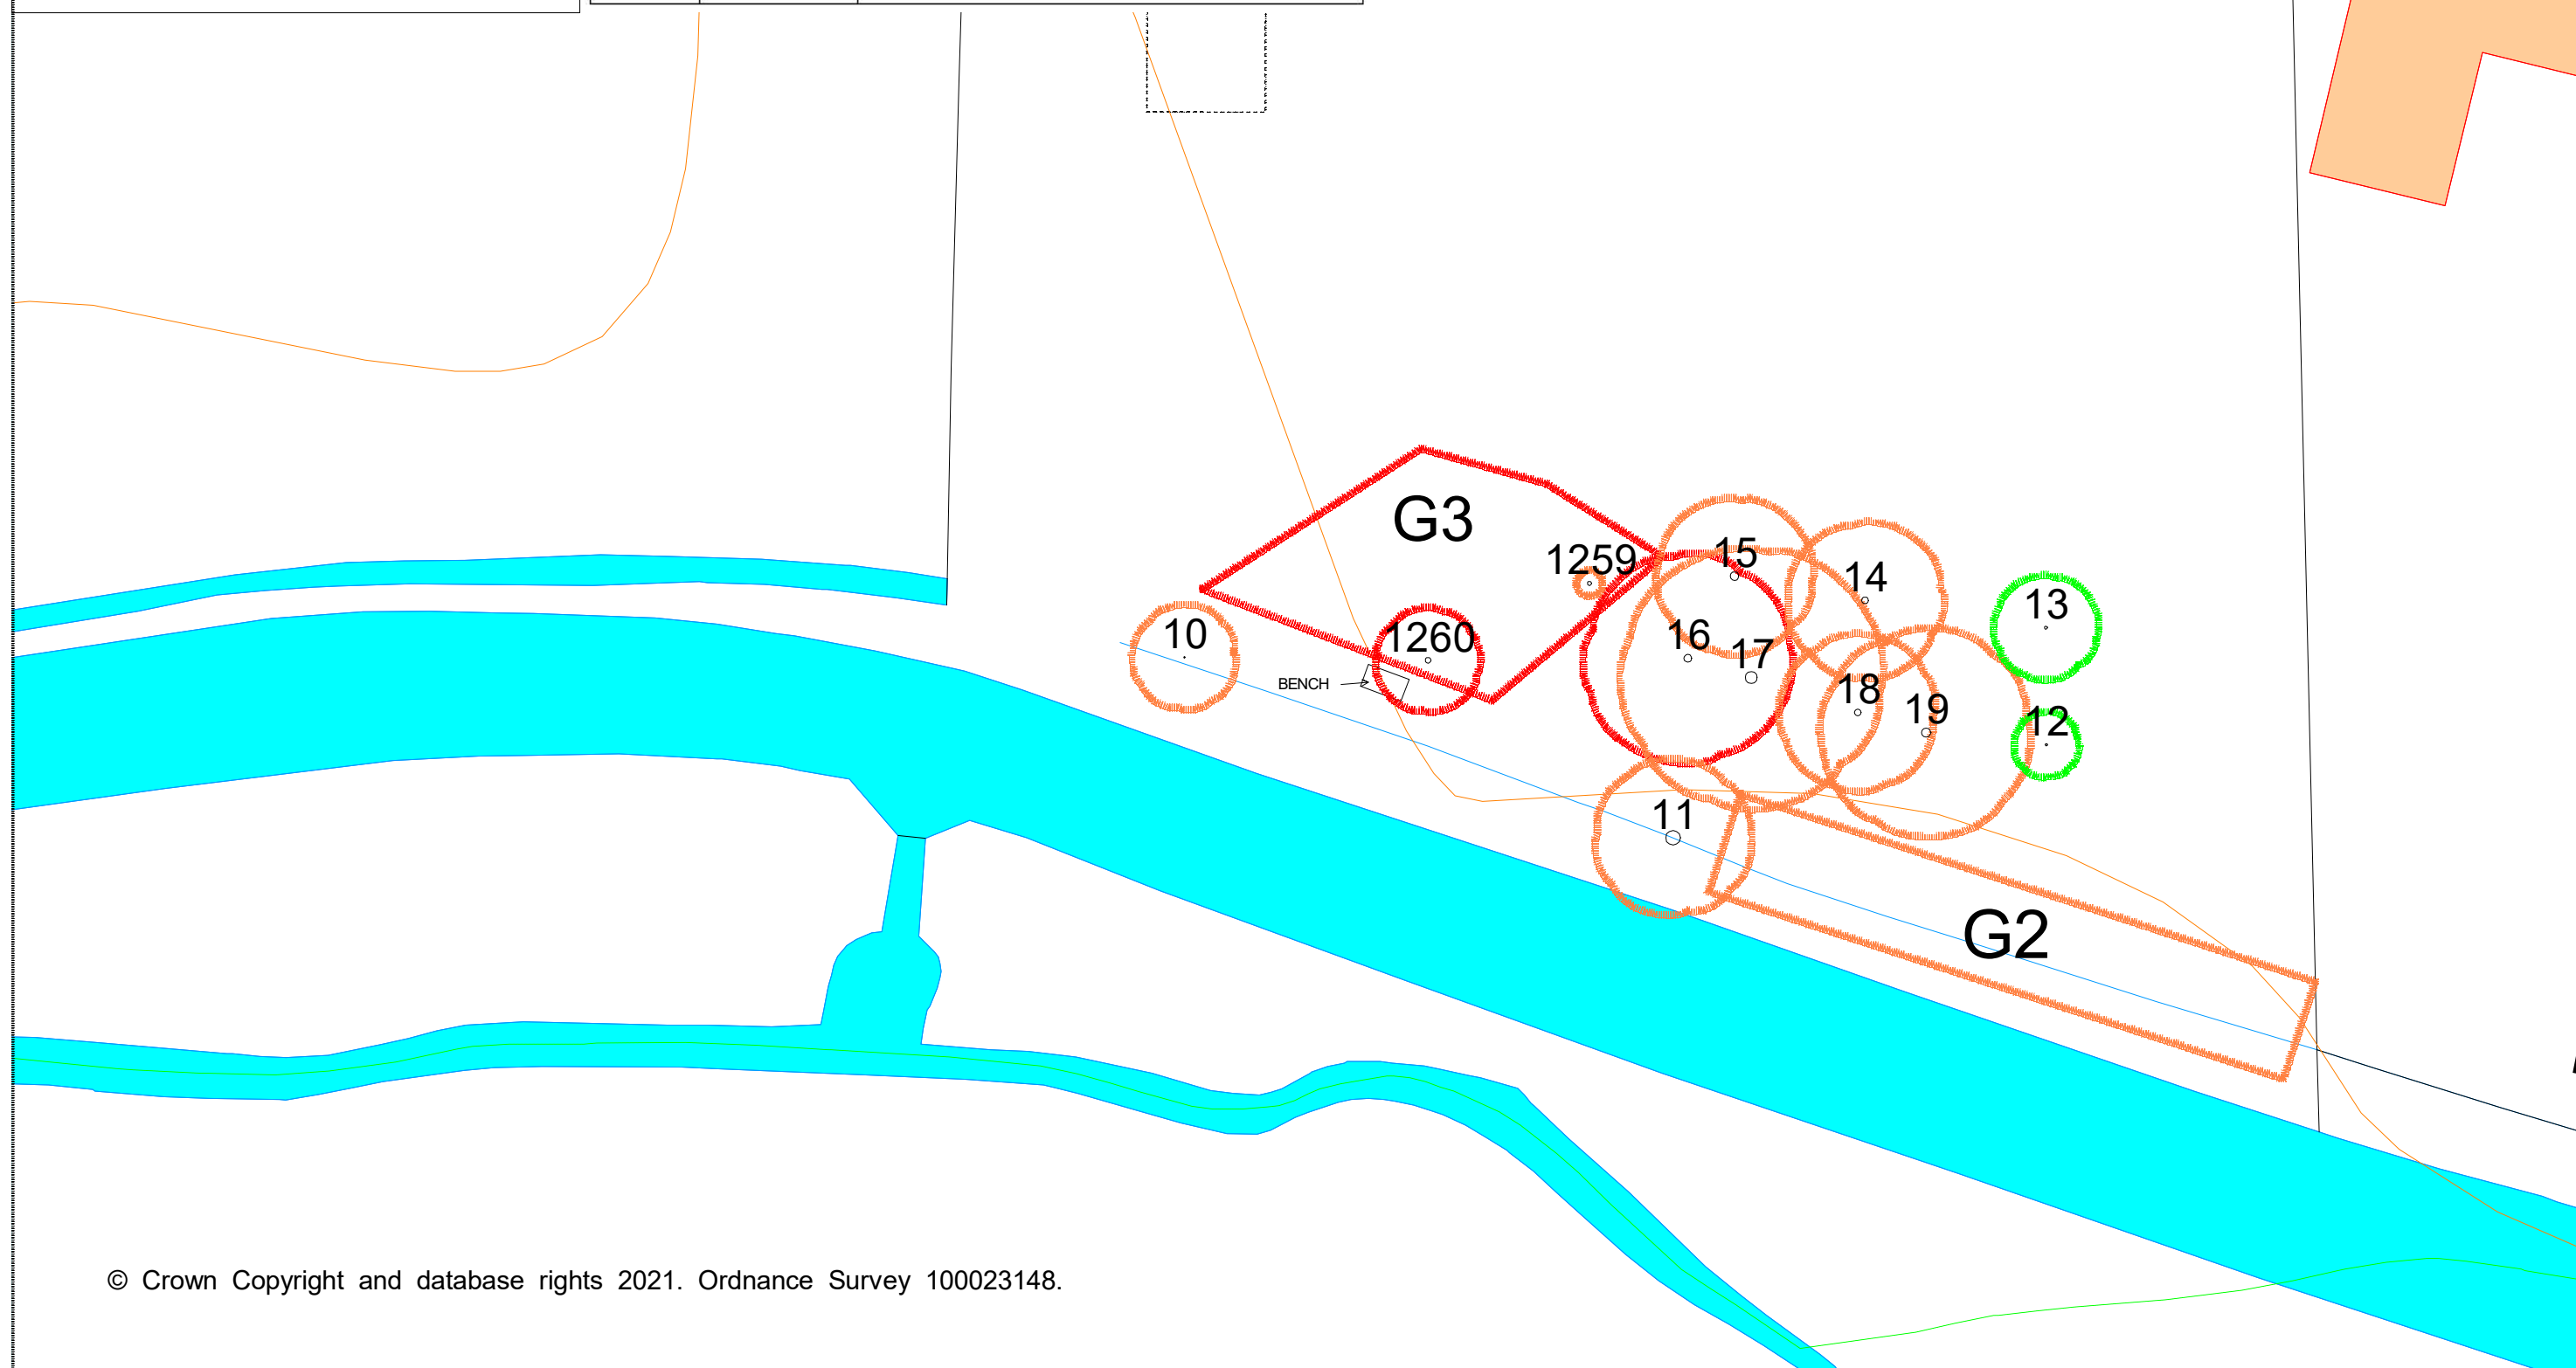
Recreation ground (south end) Great Shelford

Site name / INSET: Surveyor: Ian Lorman			Date of survey: 16 th September 2021 Conditions: Clear / dry / still					
Tree number	Species	Height estim (m)	Stem Diam (s) estim (mm) No. of	Crown spread Ave rad estim (m)	Life stage	Observations; structural / physiological condition and any tree work recommendations	Priority / urgency of work	Zone value
1	Italian Alder	20	700	7	Mature	Crown - Good, Stem - Good, Basal Area - Good Remove major dead wood Large dead branch in lower crown north west side	2	1
2	Grey Alder	16	600	7	Mature	Crown - Good, Stem - Good, Basal Area - Good No action Minor dead wood throughout	0	1
3	Silver Birch	16	500	6	Mature	Crown - Good, Stem - Good, Basal Area - Good No action Minor dead wood throughout	0	1
4	Grey Alder	16	500	6	Mature	Crown - Good, Stem - Good, Basal Area - Good Remove major dead wood Moderate dead wood throughout	2	1
5	Silver Birch	17	500	6	Mature	Crown - Good, Stem - Good, Basal Area - Good No action No notable defects	0	1

6	Grey Alder	17	650	6	Mature	Crown - Good, Stem - Good, Basal Area - Good No action No notable defects	0	1
7	Copper Beech	11	300	5	Early-mature	Crown - Good, Stem - Good, Basal Area - Good No action Excellent specimen	0	2
8	Pissards Plum	6.5	100	3	Mature	Crown - Good, Stem - Good, Basal Area - Good No action 50% reverted from basal suckers (from purple to green species)	0	2
